Manhole Inspection Summary

Manhole # S33YY1007MH

Insp Date: **1/25/07 8:26 AM**

Location Address: **5301 SPRINGLAKE WAY**

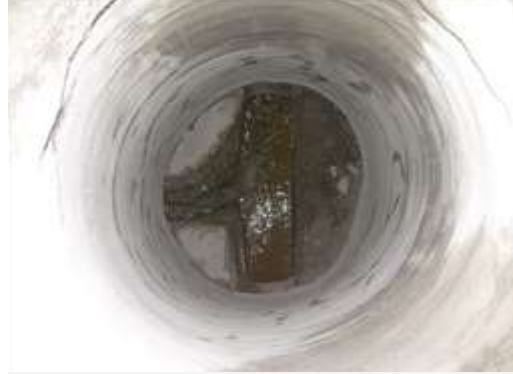
Top View

Evidence of surcharge - Bench debris

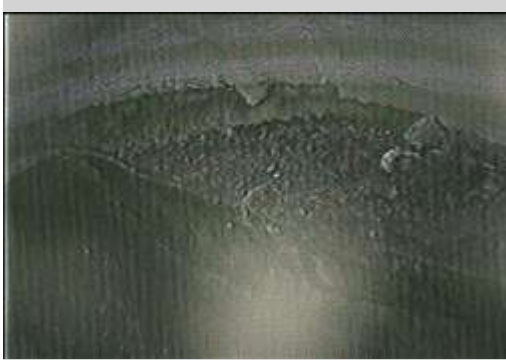
☒ **Evidence Of Surcharge**

Depth: **1** (ft.) ☐ Active Surcharge Present

Evidence of surcharge - Bench debris.

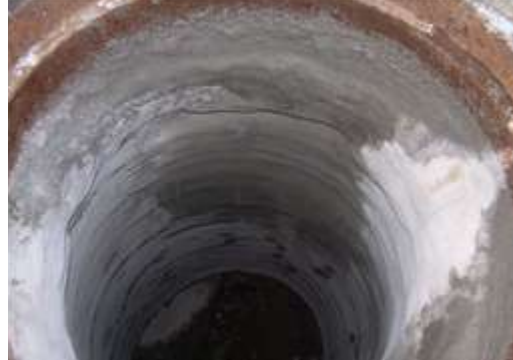
Defect

Infiltration: ☐ None ☐ Joint ☐ Cracks ☐ Mortar ☐ Roots ☒ **Wall**

Adjustment, Corbel, and Barrel infiltration.

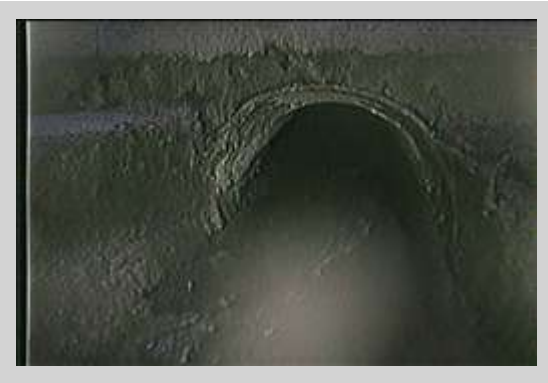
12 in. Circular Gravity Sewer Pipe Out @ 12 O'Clock

Invert Depth: **10.81** (ft.) Flow Characteristics: **Fast**

Infiltration: **None** Pipe Seal Cond: **Unknown**

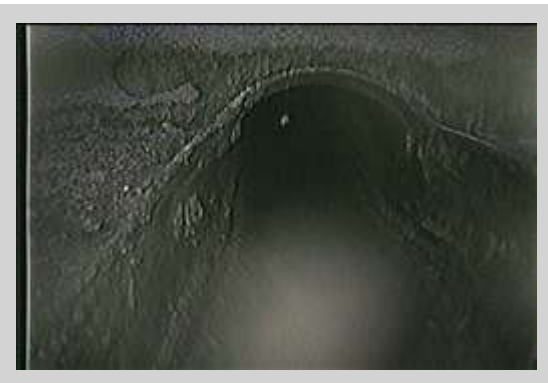
12 in. Circular Gravity Sewer Pipe In @ 6 O'Clock

Invert Depth: **10.61** (ft.) Flow Characteristics: **Fast**

Infiltration: **Evidence** Pipe Seal Cond: **Unknown**

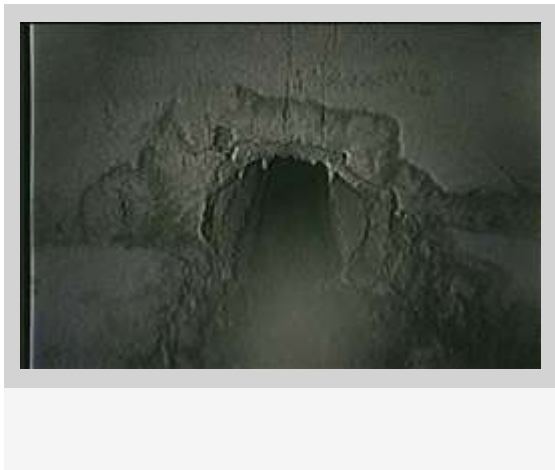
8 in. Circular Gravity Sewer
Pipe In @ 9 O'Clock

Invert Depth: **10.16** (ft.) Flow Characteristics: **Fast**

Infiltration: **Evidence** Pipe Seal Cond: **Unknown**
